Portable Induced Voltage Testing

GE's portable induced test trailers can confirm that a customer's transformer is suitable for service without the need to remove the unit from site, avoiding extensive outage time and shipping expense. They can also locate potential problems caused by corona. One key quality of the induced test is the ability to stress a transformer insulation—turn-to-turn, high-to-low, phase-to-phase, phase-to-ground, and bushing insulation—without damage. Another is that the test can locate the source of corona for an in-tank repair at much less cost than a shop repair.

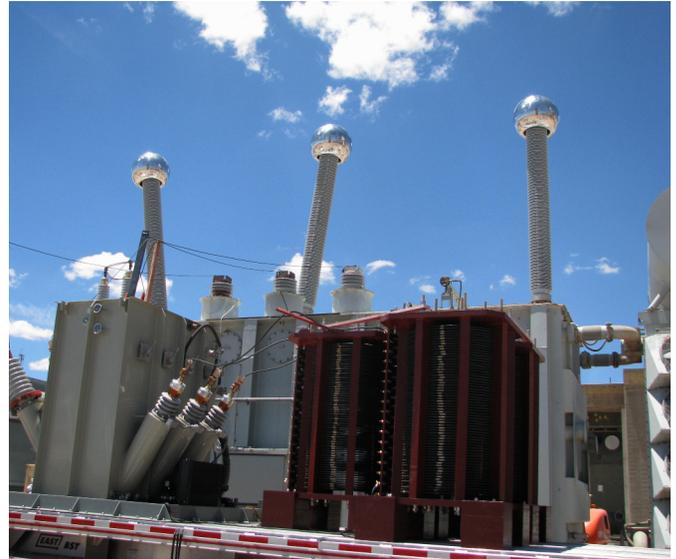
Voltage is applied to the transformer across the lowest voltage winding. The test voltage induces a voltage in the HV windings. Corona is monitored using the bushing capacitance taps of the HV bushings. This signal is fed into sensitive metering designed to measure corona. Radio Influence Voltage (RIV) and Partial Discharge (PD) are industry terms used when measuring corona. New power transformers under factory testing are expected to measure less than 100 microvolts of RIV per ANSI C57. During field tests, the results of the three phases are compared to one another.

A problem phase will typically have much higher RIV/PD. Therefore the magnitude and the relative value of each phase are important for evaluation.

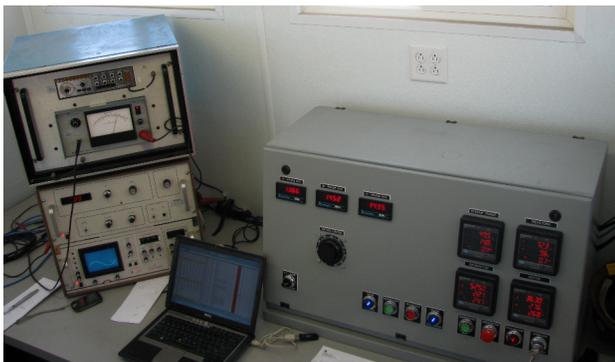
PD and RIV instrumentation
